Manhole Inspection Summary

Manhole # S31GG2003MH

Insp Date: **12/20/06 2:02 PM**

Location Address: **5718 CHARLESTOWNE DR**

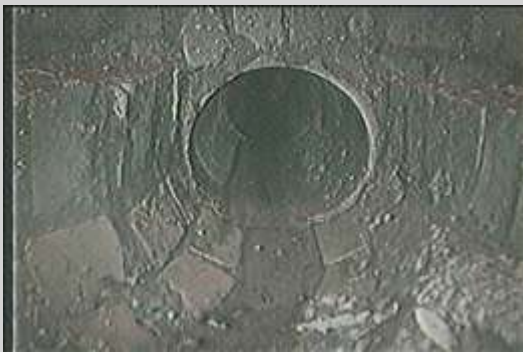
8 in. Circular Gravity Sewer Pipe Out @ 12 O'Clock

Rod and Bar (Angled)

Infiltration: **None** Pipe Seal Cond: **Unknown**
